Evaluation of the Rooftop Rainwater Harvesting Project

Study Abstract
March 2004

Water, Environment and Sanitation Section
UNICEF, New Delhi, India

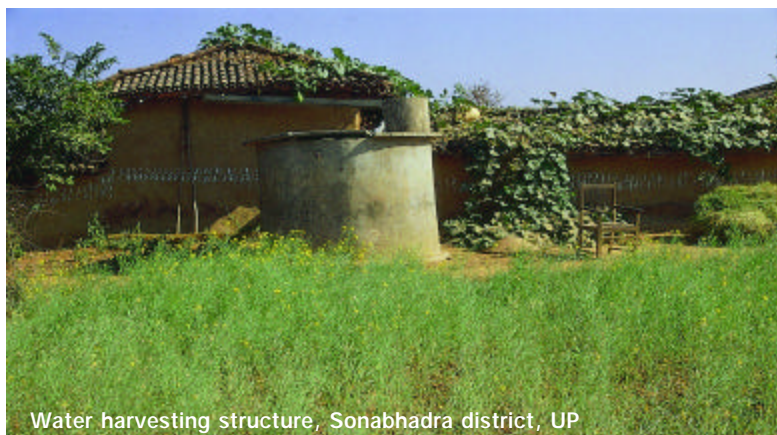
Water harvesting structure, Sonabhadra district, UP

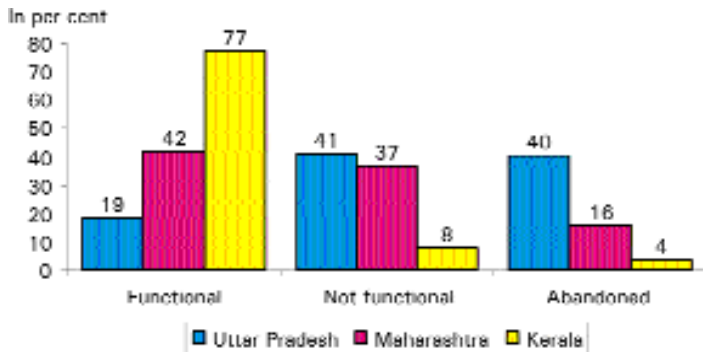
Figure 1: Status of RRH systems

The survey found that the key variables for functionality were proper construction and maintenance of the storage tanks. There were variations across the states, with the functionality ranging from 19 per cent in Uttar Pradesh to 77 per cent in Kerala (Figure 1).

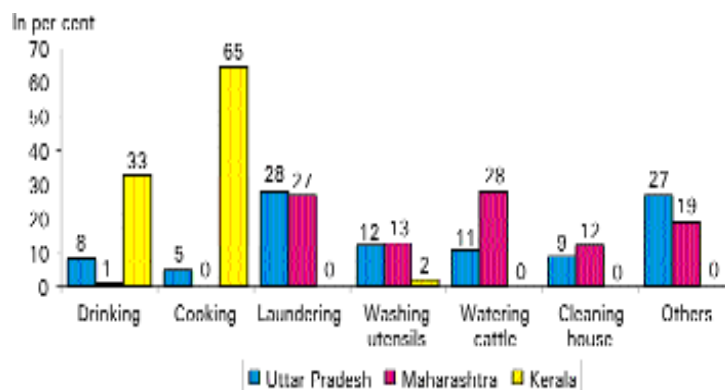
Figure 2: Use of stored rainwater

hand, households were using the collected rainwater primarily for drinking and cooking.

Stored rainwater was primarily meant for cooking and drinking. However, the respondents informed that the stored water was also used for other household purposes. It is evident from Figure 2 that in both Uttar Pradesh and Maharashtra, the collected rainwater was used primarily for household chores other than cooking and drinking. In Kerala, on the other

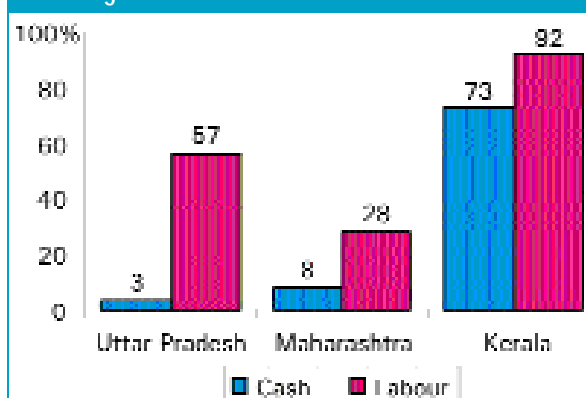
Figure 3: Contribution of user households

Figure 3 shows that the willingness to contribute towards the RRH systems was low in Uttar Pradesh and Maharashtra, while in Kerala the willingness to contribute was quite high, in terms of both labour and cash. This may be a significant factor in explaining the differences in success seen across the states.

Households that invest their own resources in the construction of RRH systems are more likely to feel ownership, which would enhance maintenance of their RRH systems. The project should impart proper training on operation, maintenance and repair of the system. ■
